BORING\_WELL2\_CASMALIA.RIFS.GPJ GEOL.GDT 12/13/10

# Well Construction Details

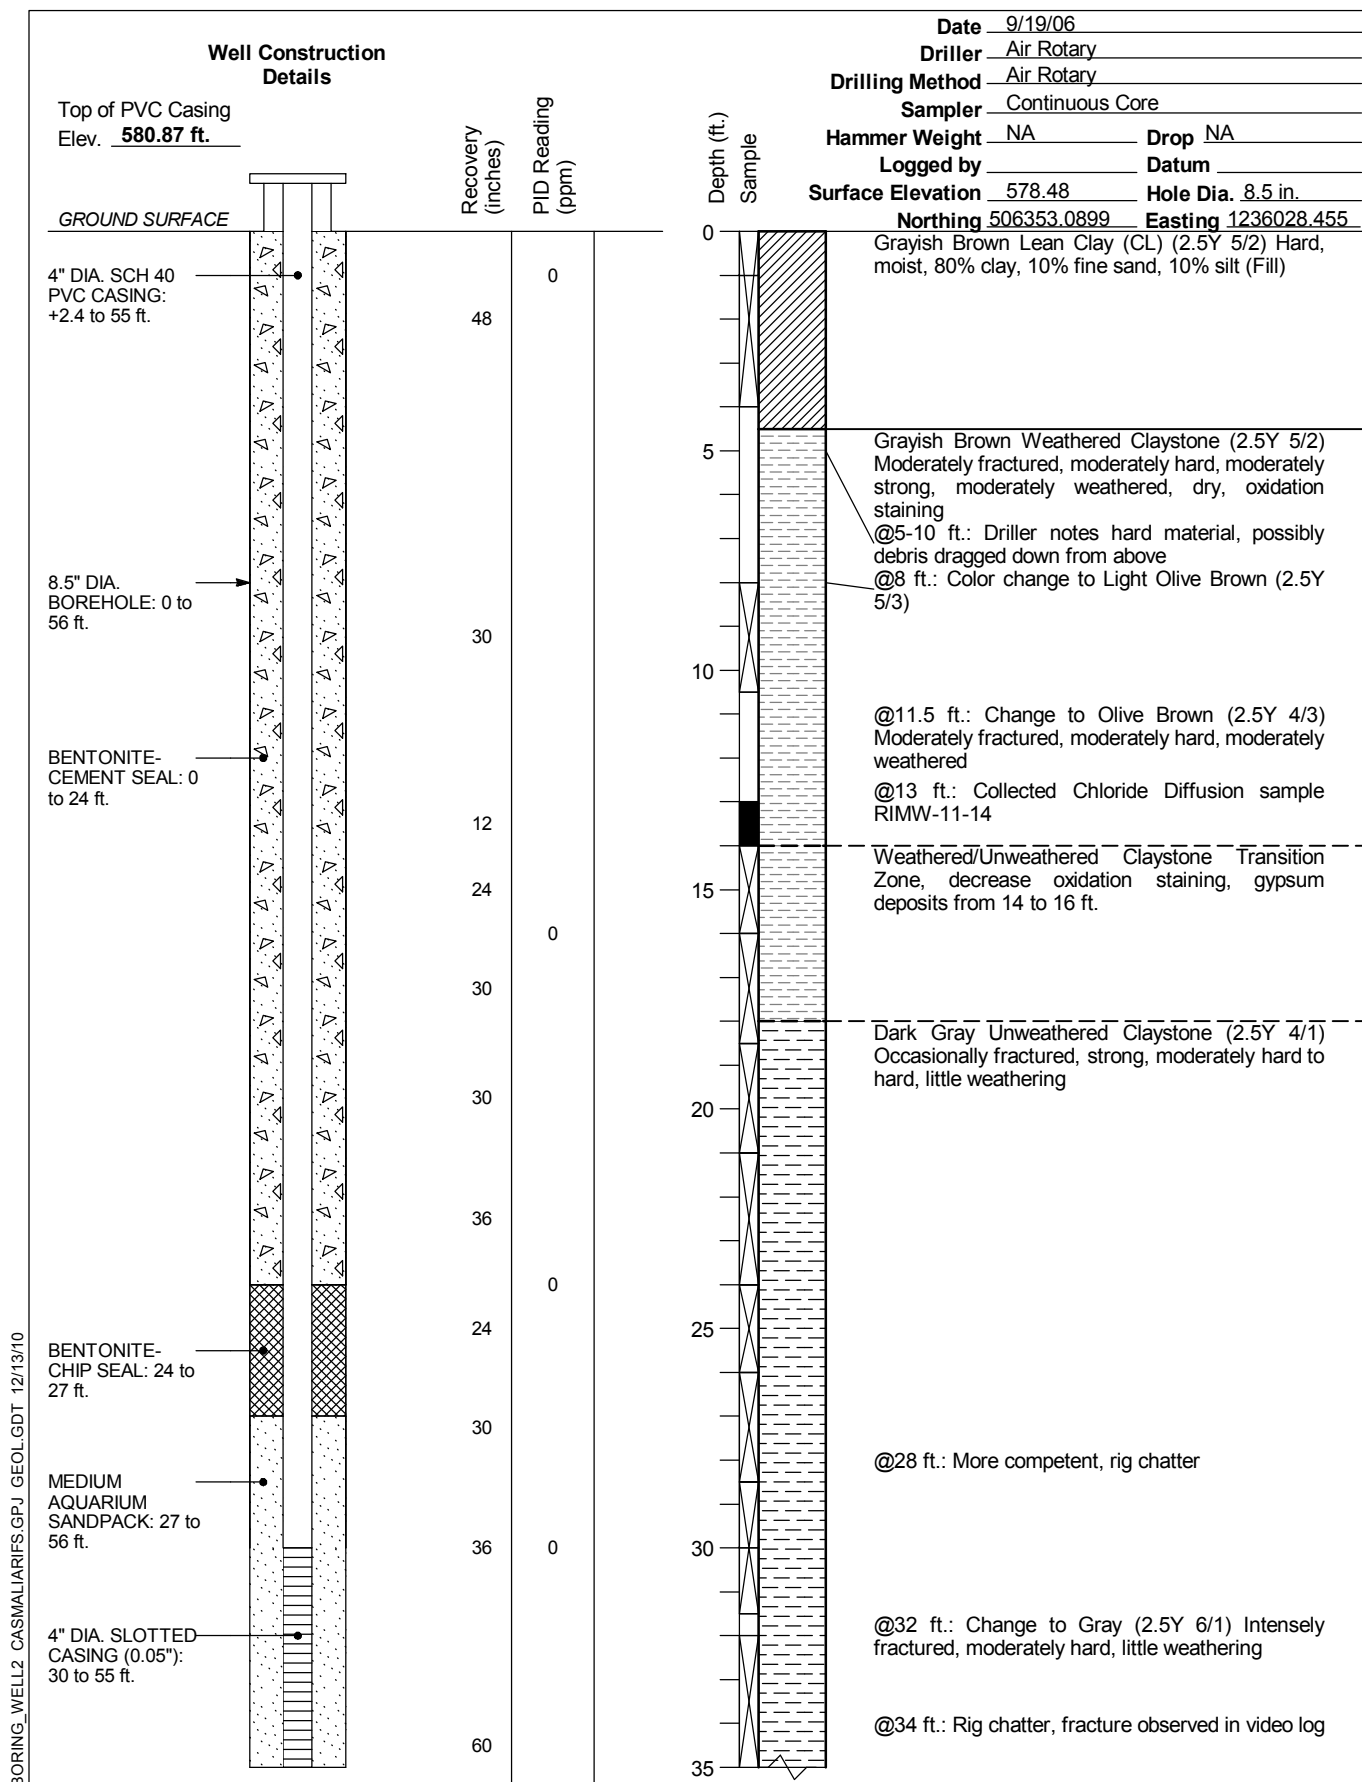
4" DIA. SLOTTED CASING (0.05"): 30 to 55 ft.

BOTTOM WELL CAP: 55 ft.  
HOLE CLEANED OUT TO 56 ft.

@37 ft.: Occasionally fractured, fracture observed in video log

@39 ft.: Water seen leaking from fracture in video log

@40 ft.: White calcite stripe observed in video log

@41.5-43 ft.: Solid core, very little to no fracturing

@43-48 ft.: Fractures or mechanical breakage, core in 2 to 3-in. pieces

@46 ft.: Vertical fracture observed in video log

@47 ft.: White stripes observed in video log

@49.5 ft.: Horizontal to subhorizontal fracture, vertical fracture observed at 49 ft. in video log

@51 ft.: Gray (2.5Y 5/1) Occasionally fractured, moderately hard, moderately strong, little weathering

@52 ft.: Vertical fracture observed in video log

Bottom of boring at 54 feet.  
Hole opened to 56 feet prior to well installation.  
Vertical fracture observed at 56 ft. in video log
